**INVESTIGATION OF FAILURES OF A
HIGH-SPEED CRANKSHAFT**

George Bjorn Lindgren
Lieutenant, United States Navy

Submitted in partial fulfillment
of the requirements
for the degree of
MASTER OF SCIENCE
IN
MECHANICAL ENGINEERING

United States Naval Postgraduate School
Monterey, California

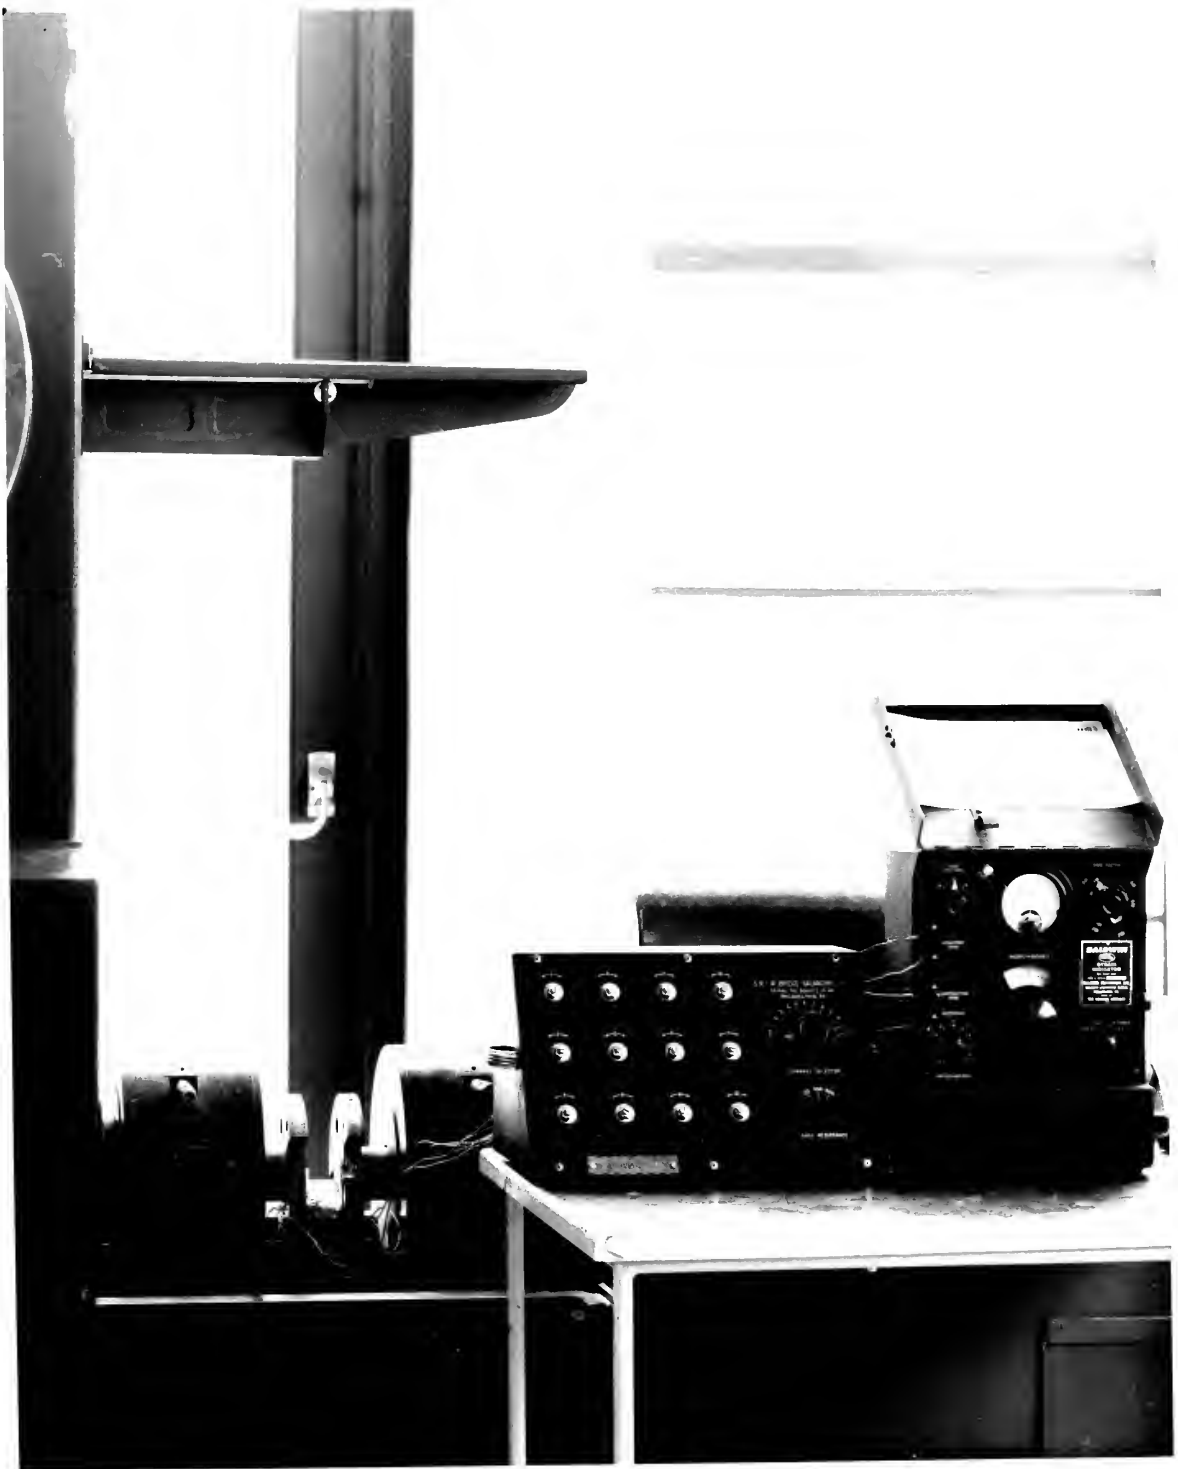
Fig. 8
Torsional Loading Arrangement for Crankshaft Study

Olsen Torsion Machine by its main journals because it was the simplest form of loading which approaches torsional loading in the actual engine. (Fig. 8) It is recognized that due to the offset of the throw a complex loading results. For the bending tests, a jig was designed to provide as nearly pure bending as possible by providing a couple at the neutral axis of the main journals. (Fig. 9) Hardened inserts were provided for the knife edges to rest upon, thereby reducing any tensile forces produced to a minimum due to digging in of the supports. The jig was designed with a distance of six inches between the top knife edges and the bottom knife edges on each side. The desired bending moment was obtained through the application of load to the center of the top T-section in the Riehle 260,000 lb. Universal Testing Machine.
